# INDIANA UNIVERSITY

## TRANSPORTATION RESEARCH CENTER

## ON-SITE AMBULANCE CRASH INVESTIGATION

CASE NUMBER - IN10036  
LOCATION - ILLINOIS  
VEHICLE - 2004 FORD E350 TYPE III AMBULANCE  
CRASH DATE - October 2010

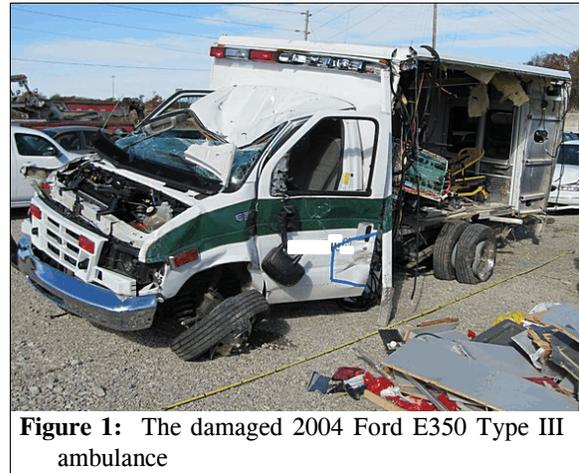
**Figure 1:** The damaged 2004 Ford E350 Type III ambulance

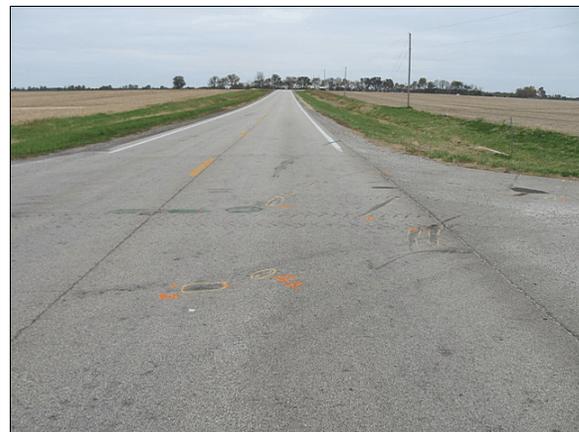
**Figure 4:** Location of impact viewed from the northbound approach of the ambulance

**Crash:** The crash occurred within the intersection (**Figure 4**) as the right side plane of the Chevrolet (**Figure 5**) impacted the left side plane of the ambulance (**Figure 6**, event 1). The left side wall of the patient compartment was torn open during the engagement between the two vehicles. The force direction on the ambulance was within the 11 o'clock sector and the calculated total Delta V was 28 km/h (17.4 mph). The longitudinal and lateral velocity changes were -20.8 km/h (-12.9 mph) and 18.8 km/h (11.7 mph), respectively. The calculated impact speeds of the ambulance and the Chevrolet were 92 km/h (57 mph) and 74 km/h (46 mph), respectively. The ambulance rotated counterclockwise approximately 10 degrees and departed the east side of the roadway. It rotated an additional 22 degrees as it traveled 15 m (49.2 ft) down a negative 18% grass covered grade to the bottom of a ditch where the right side wheels furrowed into the soil and the vehicle tripped and rolled over (event 2), right side leading, four quarter turns. The ambulance rolled over up the positive 8% back slope of the ditch and came to final rest on its wheels heading east 50 m (164 ft) north of the impact area. During the rollover, the paramedic and the patient were both ejected through the displaced left side wall of the patient compartment. The paramedic came to final rest near the left front wheel of the ambulance. The patient and cot came to final rest approximately 10 m (33 ft) directly north of the ambulance. The displaced wall of the patient compartment came to final rest approximately 4 m (13 ft) directly south of the ambulance. The Chevrolet came to final rest in the east ditch 15 m (49 ft) north of the impact area.

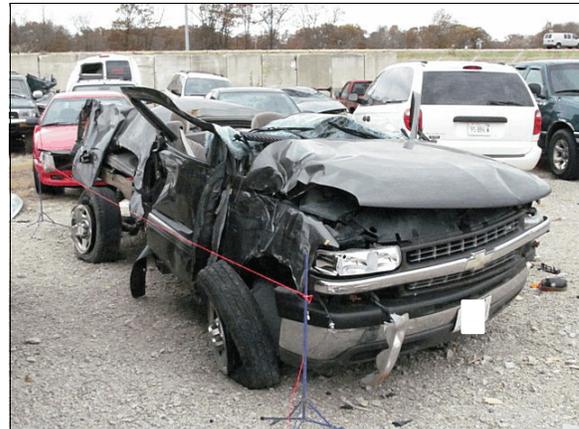
**Figure 5:** Damage to the right side plane of the Chevrolet from the impact with the left side plane of the ambulance

**Damage Classification:** The CDC for the right side damage was 05RDAW4 (140 degrees). A conservation of linear momentum analysis was performed and the calculated total Delta V was 64 km/h (39.7 mph). The longitudinal and lateral velocity changes were 47.3 km/h (29.4 mph) and -43.0 km/h (-26.7 mph), respectively. The calculated impact speed was 74 km/h (46 mph).

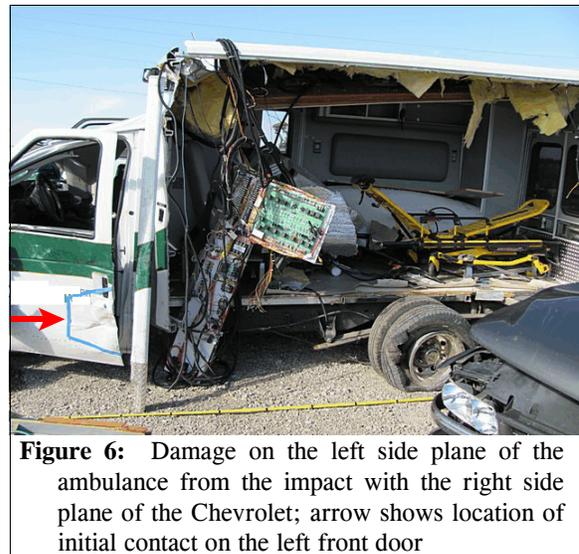
**Figure 6:** Damage on the left side plane of the ambulance from the impact with the right side plane of the Chevrolet; arrow shows location of initial contact on the left front door

**Exterior Damage Event 1:** The ambulance sustained left side plane damage from the impact with the Chevrolet. The direct damage began on the left front door 253 cm (99.6 in) forward of the left rear axle. The direct damage was 43 cm (16.9 in) in length on the left front door and extended onto the left side plane of the patient compartment. The entire left side wall of the patient compartment was torn off the vehicle during the crash. The wall was constructed of sheet aluminum that was attached to a welded aluminum frame by adhesive caulk (**Figure 7**). The frame of the wall was constructed of welded 5 cm x 5 cm (2 in x 2 in) aluminum studs. The inside surface of the wall was constructed of plywood. The wall was insulated with fiberglass. The frame of the wall was welded to the front, back, top, and floor of the patient compartment. All of the left side wall studs broke at their welds on the frames of the front, top (**Figure 8**), back (**Figure 9**), and floor of the patient compartment.

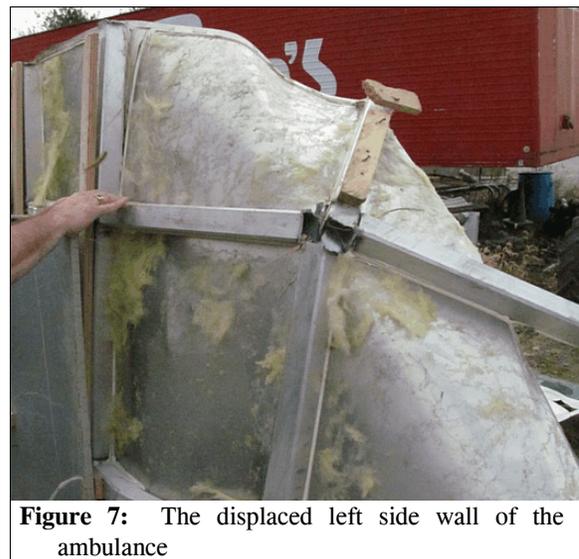
**Figure 7:** The displaced left side wall of the ambulance

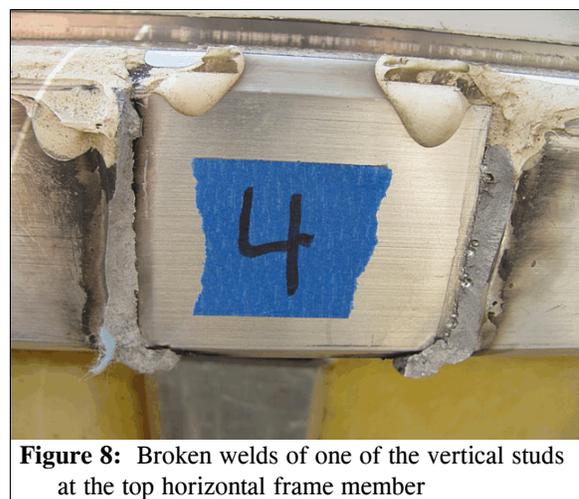
**Figure 8:** Broken welds of one of the vertical studs at the top horizontal frame member

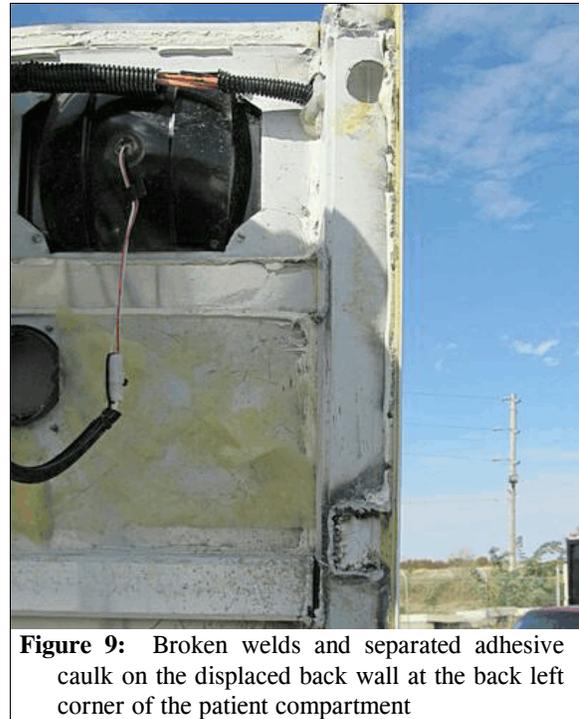
**Figure 9:** Broken welds and separated adhesive caulk on the displaced back wall at the back left corner of the patient compartment

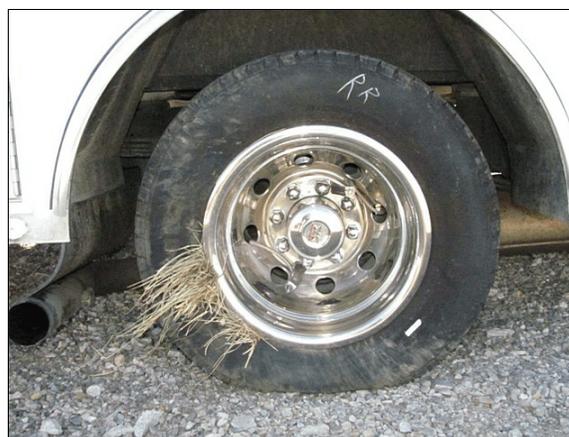
**Figure 10:** Grass entrapped in the bead of the right rear wheel of the ambulance from engaging the back side of the ditch

wheel (**Figure 10**) sustained the primary load when it entered the channel at the bottom of the ditch and engaged the back side of the ditch (**Figure 11**). The force on the right side wheels was sufficient to trip the vehicle and it rolled over, right side leading four quarter turns up the positive 8% back slope of the ditch and across a distance of 21 m (68.9 ft). During the rollover, the vehicle continued to rotate counterclockwise and it came to final rest heading east.

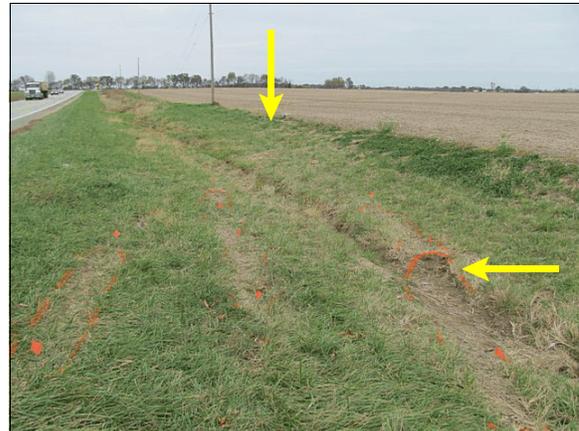
**Figure 11:** Arrow in foreground shows deep furrow on back side of ditch from right rear wheel of the ambulance; arrow in background shows the final rest location of the ambulance.

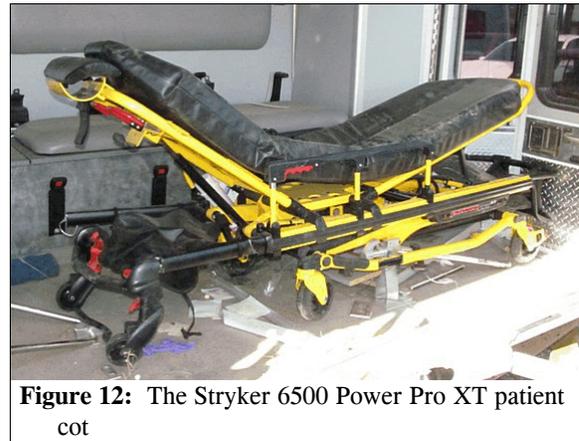
The cot that was used to transport the patient was a Stryker 6500 Power Pro XT (**Figure 12**), serial number 081039975. The cot was an aluminum x-frame design and its maximum weight capacity was 318 kg (700 lbs). It was equipped with a 24 volt battery hydraulic lift system. The standard length and width was 206 cm (81 in) and 58 cm (23 in), respectively. Its lowest adjustable position was 36 cm (14 in) and the highest was 105 cm (41 in). No patient restraints were on the cot at the time of the SCI inspection. The ambulance driver stated that the patient was

**Figure 12:** The Stryker 6500 Power Pro XT patient cot

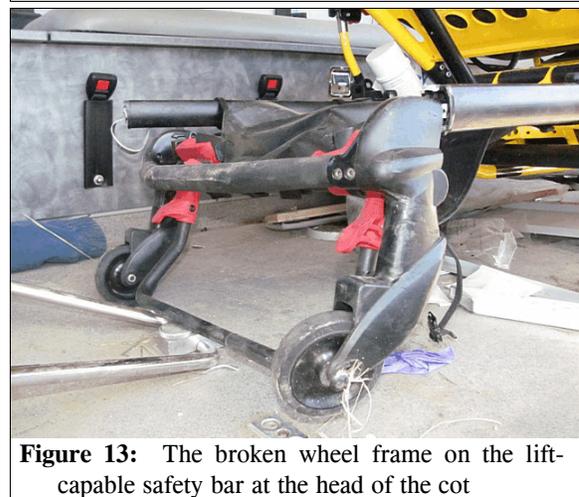
**Figure 13:** The broken wheel frame on the lift-capable safety bar at the head of the cot

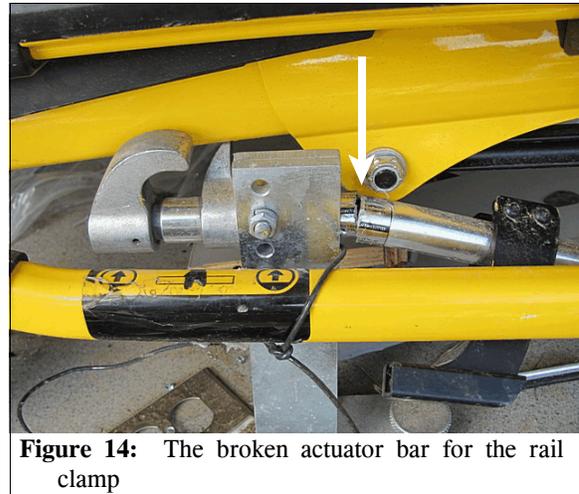
At the time of the crash, the cot was secured by the ambulance's antler bracket and rail clamp. The antler bracket secures the head of the cot by restraining the undercarriage using the wheel frames as anchor points. The rail clamp secured the frame of the cot. Inspection of the cot revealed that the wheel frame on the lift-capable safety bar at the head of the cot was broken at the end of each frame rail (**Figure 13**). The dimensions of the frame rail were 5 cm x 3 cm (2 in x 1.2 in). The left frame rail was bent 2 cm (0.8 in) to the left, while the right frame rail was bent slightly. A scuff mark 8 cm (3 in) in length was present on the right frame member at the head of the cot. The actuator bar for the rail clamp was fractured (**Figure 14**). The plastic housing on the right grip rail at the foot end controls was also fractured.

**Figure 14:** The broken actuator bar for the rail clamp
